AOMCC SQUARE FOUR CON-RODS - PART NO 1111-04

IMPORTANT - clearance between rods and liner spigots.

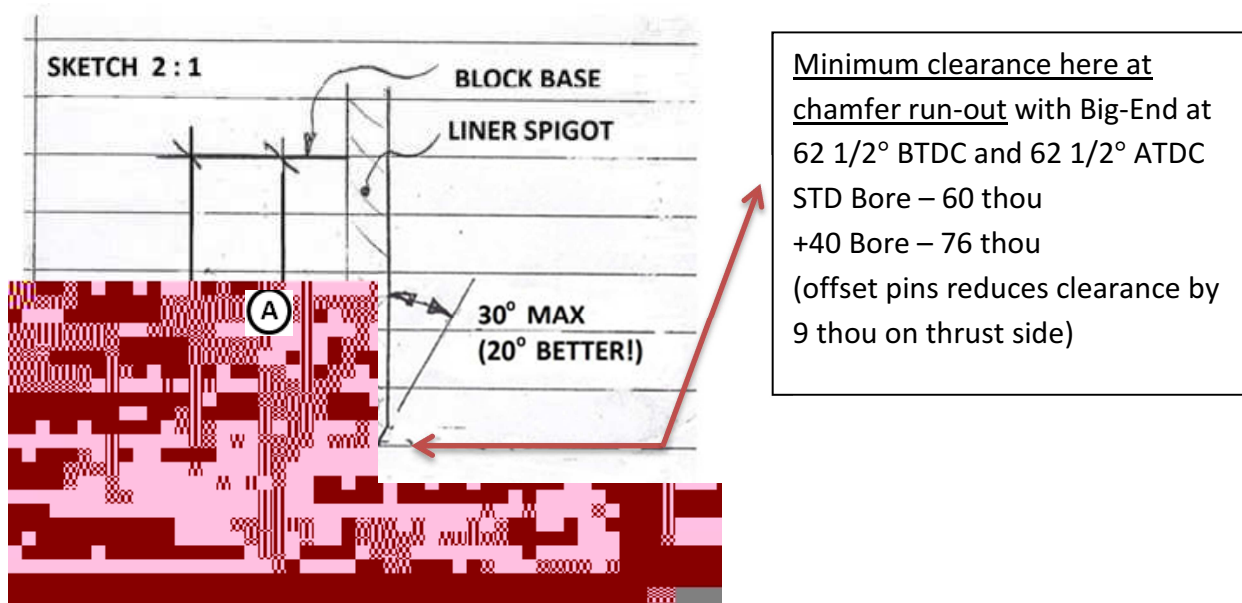
Problems with lack of clearance have been identified in engines that have blocks faced off and then counterbored to allow flange of liner to seat fully – this allows liner spigot to protrude too much into crankcase. Situation not improved if block base also faced off. Some pattern liners are too long and/or with incorrect lead-in chamfer.

* Use above sketch to check liner spigots!

- The most important dimension is the run-out of the chamfer at (A) below block base.

DIMENSION A - STD 18mm, +20 18 1/2mm, +40 19mm

If liner spigot requires correction, this can be done without removal

- Adjust chamfer where rod comes close for 3/4" width and run-out at (A) from base.

OR

- Cut slots 3/4" wide with bottom (A) from base plus small chamfer.
